## 8.0 Great Pond Bay Watershed

### 8.3 Potential Watershed Restoration/Project Sites

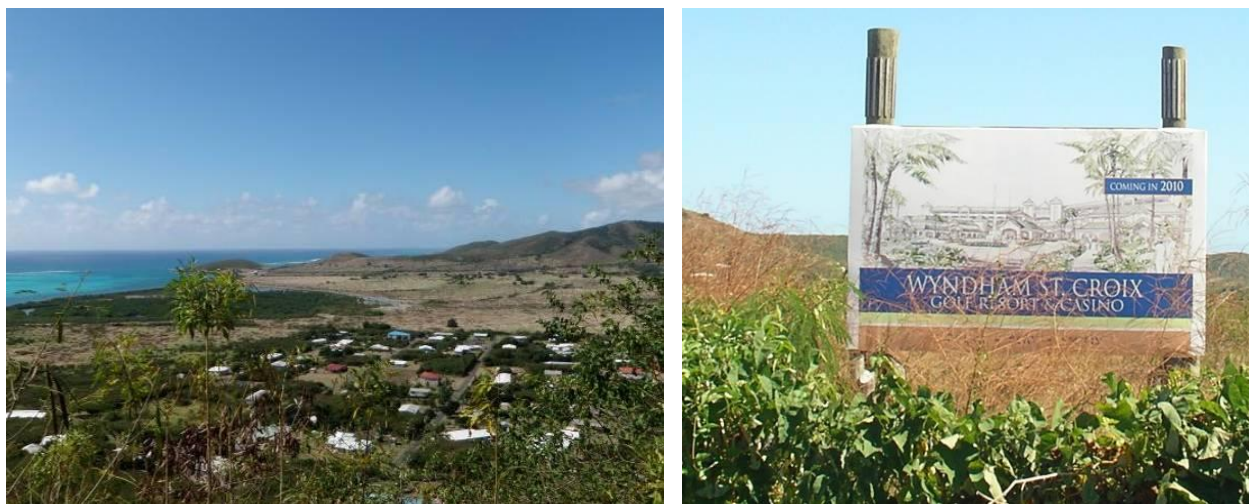
Three main roads effectively separate the Pond and surrounding lowlands from the steeper terrain: South Shore Road in the east, Southside Road (Rt. 62) in the west, and Route 624 connecting the two. Land use in the watershed consists of a large Boy Scouts of America Camp in the west, a public camping ground (Arawak) and the East End Marine Park (EEMP) Offices in the east, and a small grocery store (Milgie's). Several low-density, single family neighborhoods are located in the watershed: Union & Mt. Washington, Marienhøj, and Sally's Fancy. The watershed is mostly zoned for agriculture and low density residential; however, a portion of the watershed was up-zoned high density, associated with the proposed Robin Bay Resort development and, presumably, the Wyndham Golf Resort/Casino (Figure 8.1). North of Rt. 624 is a proposed commercial retail center, the Muddy Mongoose.

**Figure 8.1.** Overlooking Great Pond and the Union neighborhood from Mt. Washington (left), and signage indicating new proposed development (right).

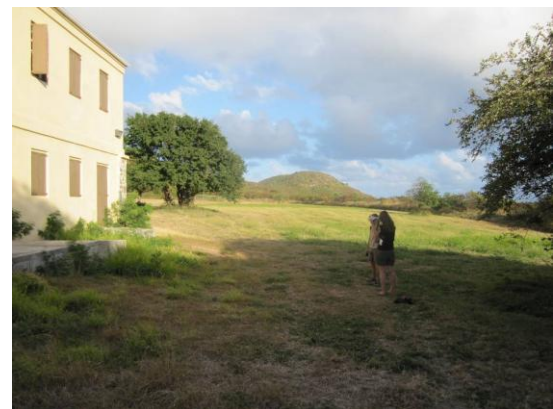
#### *East End Marine Park (EEMP) Office (GP-R-2)*

The EEMP office is a small, two-story building just east of Great Pond, adjacent to the historic Great House. Since rooftop runoff is collected in cisterns, the area is generally flat, and there is limited erosion evident in the parking lot or immediate vicinity, no stormwater drainage demonstration projects were identified. However, the park office is surrounded by a lot of open area, which could potentially be converted into a demonstration/study area for growing native plants for use in demonstration projects elsewhere on island (Figure 8.10). Part of the educational program of the EEMP could include how to convert residential lawns to native landscaping.

**Figure 8.10.** Eastern side of EEMP office building is a potential location for demonstration garden.

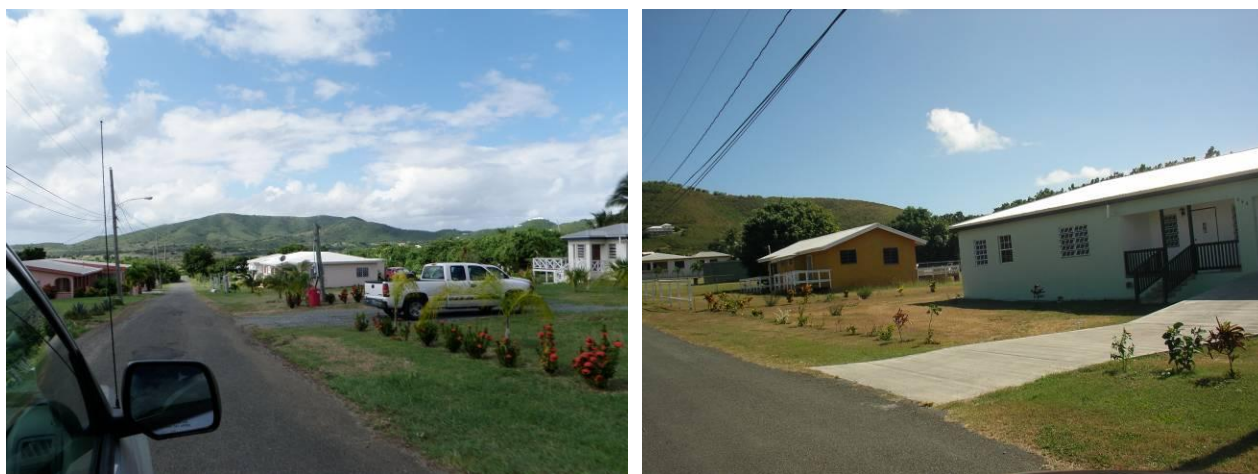
The Union area is the flatter portion of the greater Union/Mt. Washington neighborhood. It is located northeast of Great Pond and off of South Shore Rd, and is relatively flat compared to many of the other residential areas in the East End (Figure 8.14). The primary roadways within this area are Sunset Road, Corry Road, Tamarind, David Oliver, Seaview, Blue Dolphin, Kenjo, and Acacia. The Union area is approximately 115 acres with 302 lots, less than 25% of which remain undeveloped. Average lot size for the single family homes in this neighborhood is around 0.25 acres, however, there are larger lots. Average lot cover is 70% turf, 25% rooftop, and 5% bare soil. Wastewater is managed via on-site septic systems and no problems with septic were observed. Road cover was mixed, but mostly paved. One section of Kenjo Road was unpaved and eroded with large ruts. All roads had open drainage and there was no evidence of water bars or culverts. A few roads had shallow grass swales on the road shoulder. This neighborhood does not appear to pose as a source of pollutants or sediment to down-gradient resources.

**Figure 8.14.** Street view of the Union area.
